HISTORIC SONORA DOME FEASIBILITY STUDY

Introduction

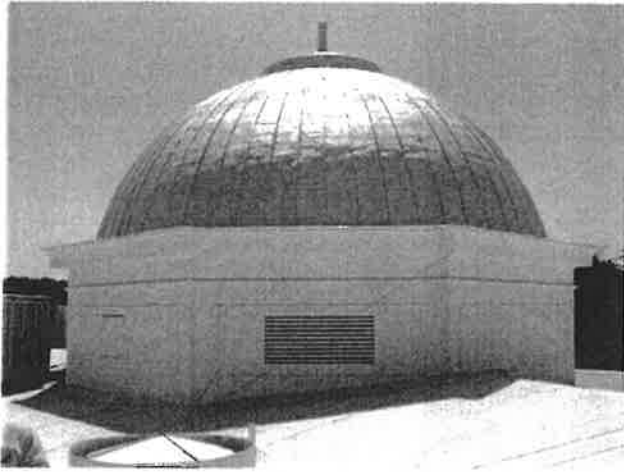
Photo2.1: The dome as seen from the roof. The original sheetmetal roofing has been covered with foam roofing.

The foam roof system on the main building does not alter the historic integrity of the building, as the roof is not an integral aspect of the exterior look of the building. However, the foam over the dome portion of the roof does effect the original texture and color of the historic roofing and should be removed. The foam could be removed and the original sheet metal roof restored or replaced with like materials.

Single-ply membrane roofing over the total roof surface. A new flat sheet metal roofing over the dome to replicate the original roofing and restore the historic look of the dome.

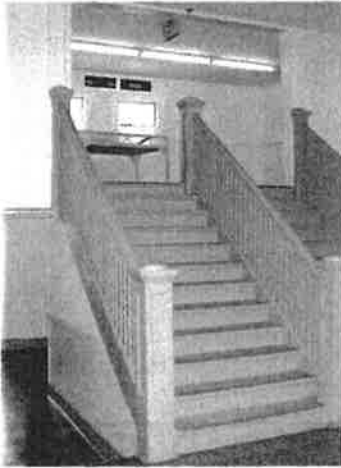
Photo 3.1: Main Stair at the front entry. It also steps down to the left of the stair. The landing seen in this photo is only about half way up to the 2nd floor level.

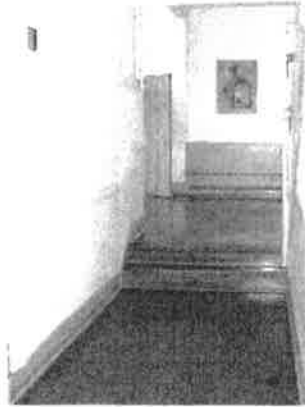
Photo3.2: Change in level at the hallway on the 1st floor level.

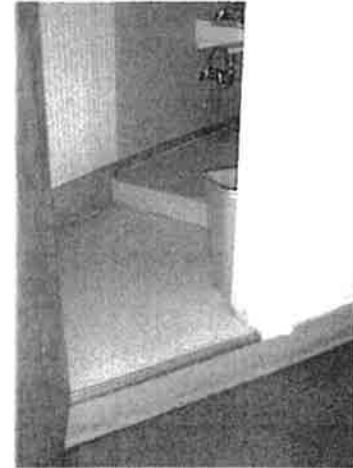
Photo3.3: Hallway to restroom change in levels.

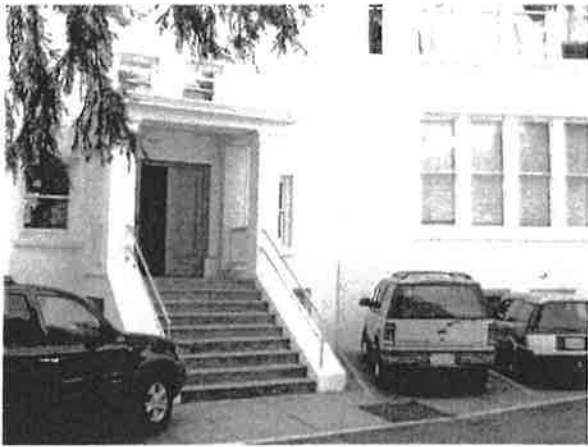
Photo 3.4: Back entry stairs. The proposed detached elevator would be set to the right of the stair

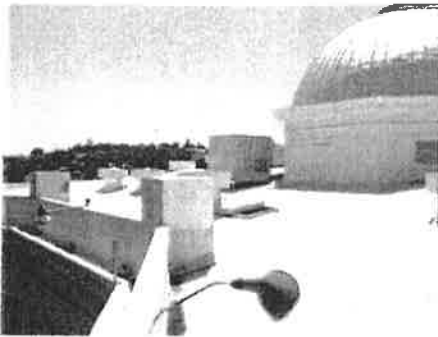
Photo 5.1: Roof mounted swamp cooler for the dome space to the left of the dome.

The reuse of this structure should require a new HVAC system to be designed and installed. This system should be capable of separating each floor and each individual space. This should be accomplished for both energy efficiency and for leasability.

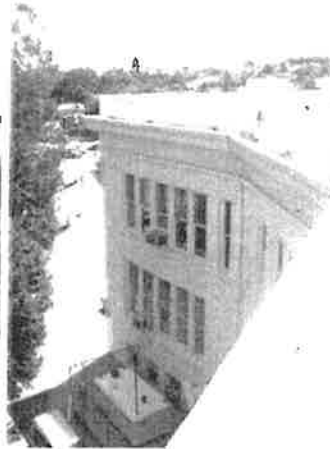
Photo 5.2: Window mounted air-conditioning units on the back side of the building.

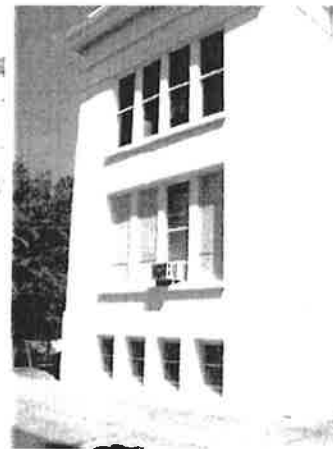
Photo 5.3: Window mounted air-conditioning units on the front side of the building.

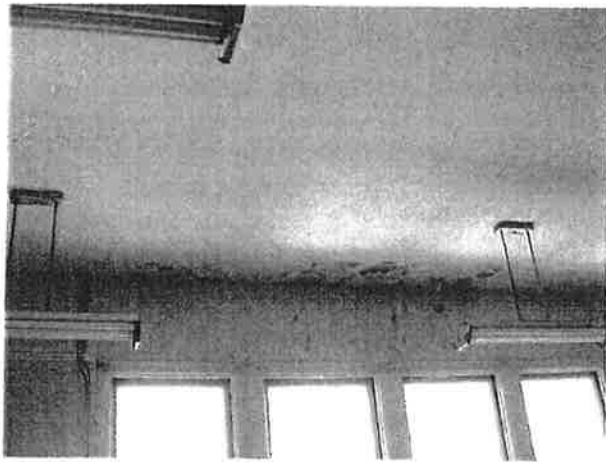
The second floor is exhibiting much more damage than the lower floor. Most of this damage was caused by leaks through the original roofing.

Photo 7.1: Water damage at the 2nd floor ceilings and walls.

Most if not all of these leaks were repaired when the roof was covered with foam roofing. We recommend removing the roofing down to the original roof sheathing as indicating in the structural section above. Structurally we can improve the roof diaphragm and then install a single ply roofing system. Although this is not a historic roofing system it is one of the most cost-effective roofing systems when you factor in durability, ease of maintenance and longevity. As this roof cannot be seen when looking at the building from any viewpoint we believe it will not detract from the building's exterior appeal. The Dome itself on the other hand should be restored with flat seam sheet metal roofing to match the original roofing. This roofing is essential to the overall appearance of the building. Today's metal roofing materials will provide an excellent method to cover the dome. Designed, installed, and maintained correctly the metal roofing should not leak and will provide as many years as the single ply roofing system. The second floor ceilings and walls should also be restored from the water damage and the damage that may be caused by the structural retrofit. The Auditorium has been recently upgraded with paint, carpet and light fixtures and it looks beautiful. However, there is though additional work to be completed here as well. The plaster ceiling is showing cracks and stresses. Restoration should be performed to ensure that the ceiling is secured to the structure above. Cracks should be repaired. The woodwork and painting should be restored to bring back the original luster. The stage is showing some wear and should be restored. The reality is that the total interior of the building needs a general cleaning and "sprucing" up. This would include new interior finishes such as paint and carpet. A color scheme should be set and maintained for the entire building as a whole. This scheme could be based on the historic/original colors if evidence of this scheme is still available or an entirely new scheme could be provided.

Repair of ceilings removed for structural ties and diaphragms. Repair of walls that have water damage.

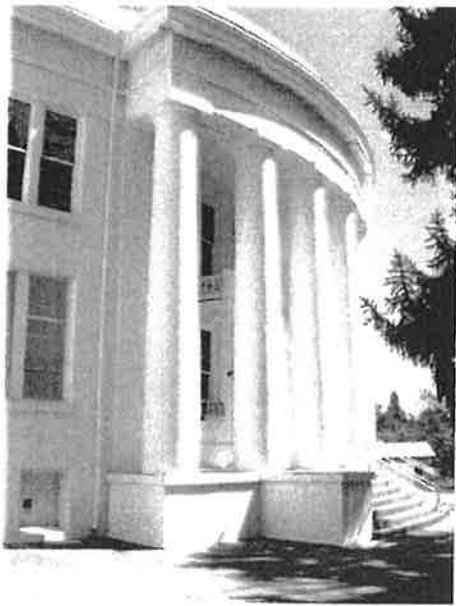
Photo 8.1: Front entry from the north. Notice the window mounted air-conditioning unit in the lower window at the porch.

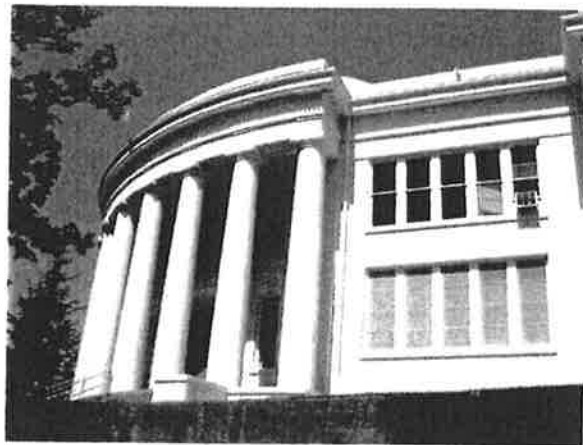
Photo 8.2: Southwest view of the building. Another window mounted air-conditioning unit.

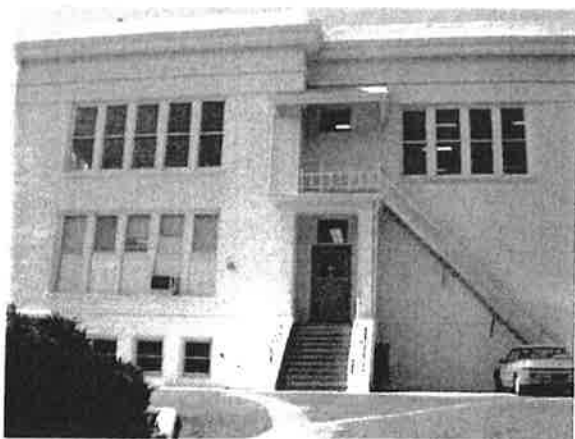
Photo 8.3: Southside elevation. View shows the multiple levels of the building.
