HISTORIC SONORA DOME FEASIBILITY STUDY

Introduction

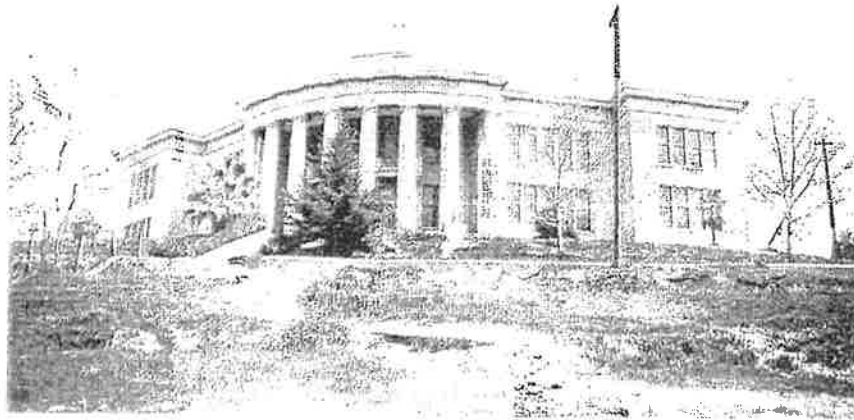
Photo 1.1: Historic Sonora Dome Building recently completed c. 1910

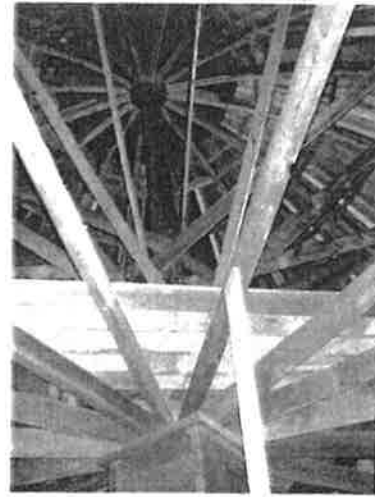
Photo2.2: The Interior framing of 2 dome roof system.

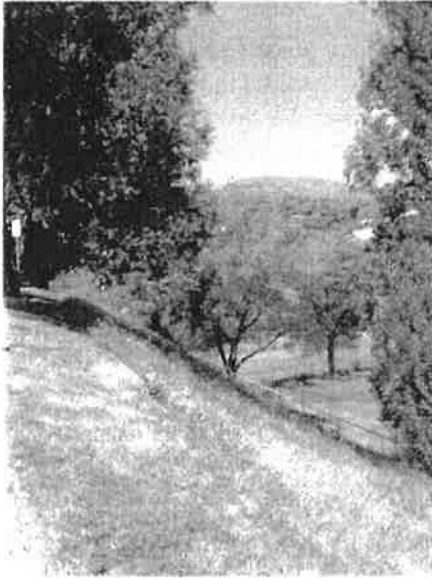
Photo 4.2: Current view behind the dome building looking to the north and east. Looking towards the soccer field, one possible location for the future parking garage.

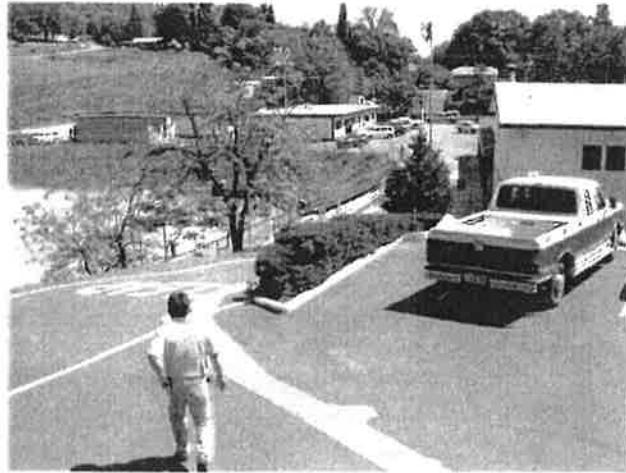
Photo 4.3: South and east of the dome building. In the distance is the portable school buildings and adjacent parking. One possible location for the future parking garage or lot.

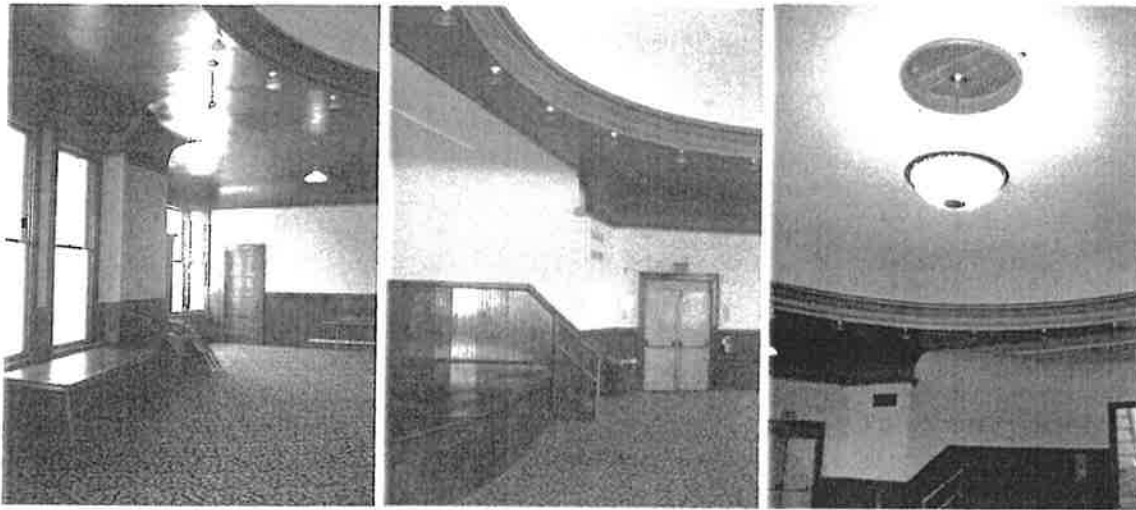
Photos 6.1, 6.2, and 6.3: Auditorium or Dome Space. Notice the large double hung wood windows, high ceiling, and the extraordinary dome ceiling.

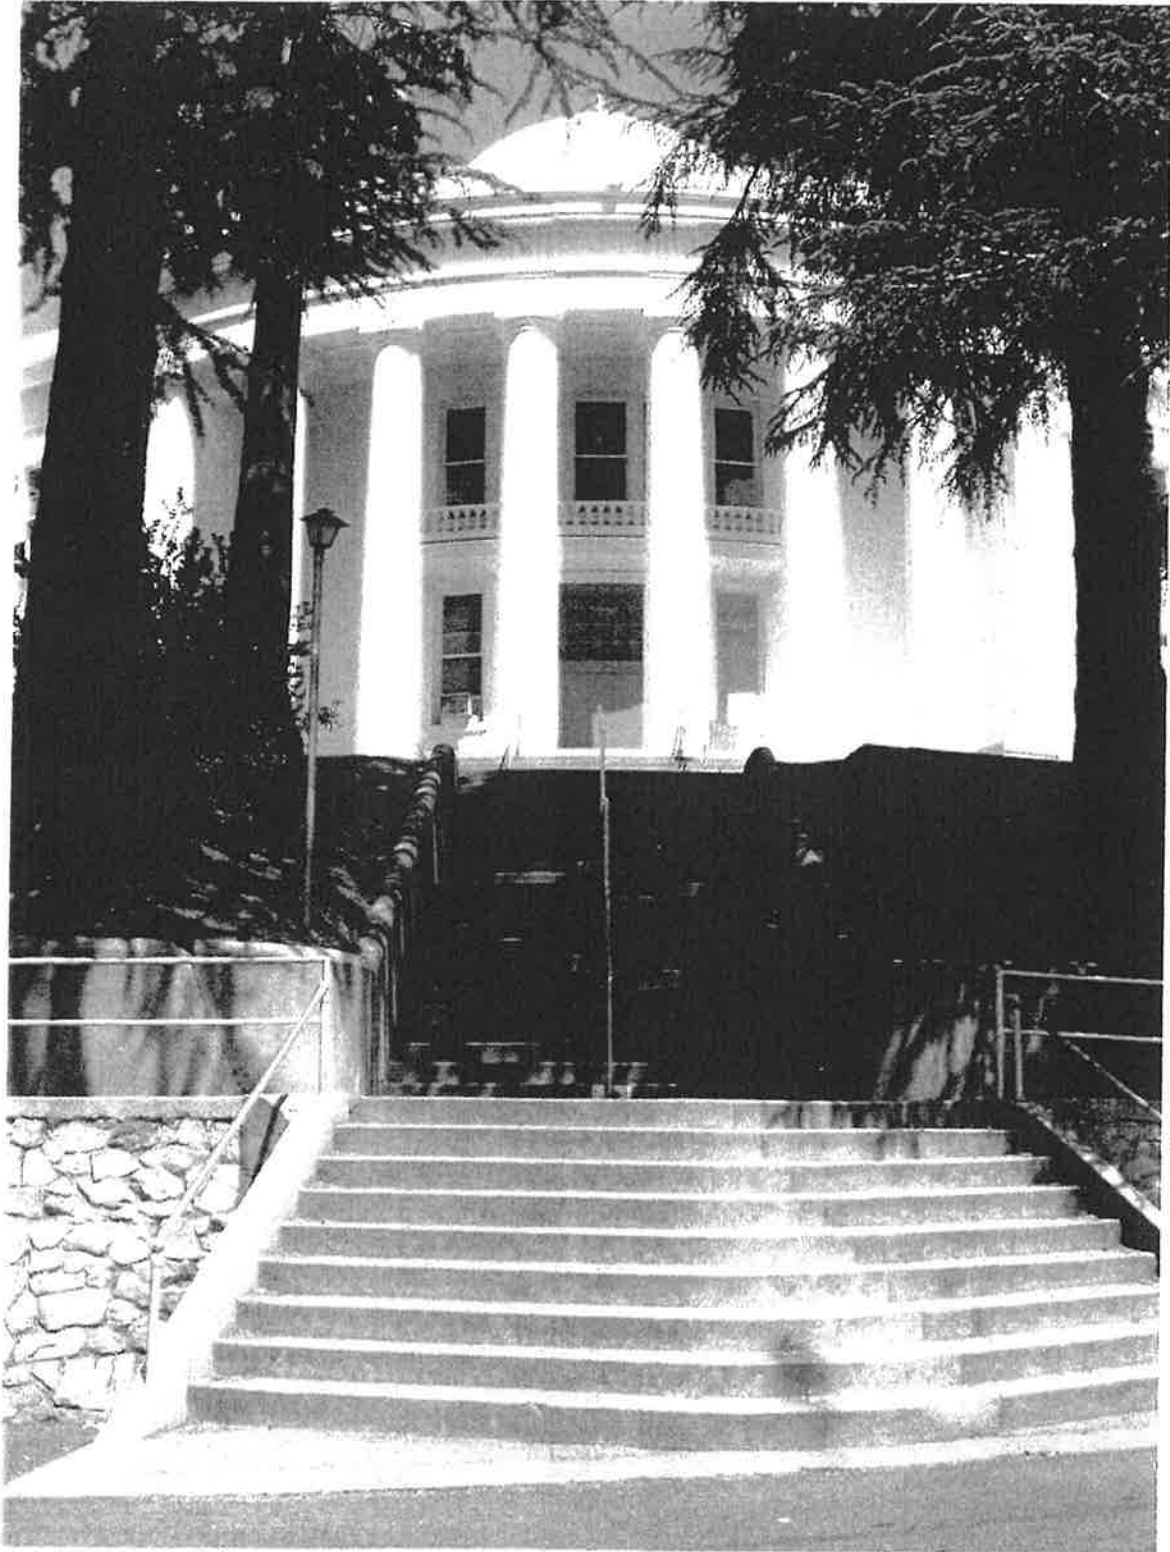
Photo 9.1: Front Entry view from South Barretta looking up the stairway from the bottom of the hill.
